3. Guidelines for Historic Properties

This chapter presents design guidelines that apply to all properties which are considered to be historic resources in the Houston Street area. Some properties have been identified in historic surveys, while many others that may not be officially designated may also have significance. In general, a building must be at least fifty years old before it may be evaluated for potential historic significance.

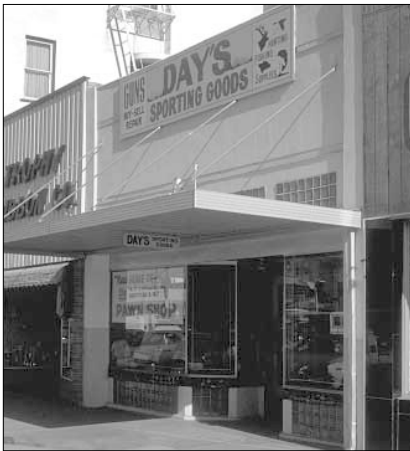
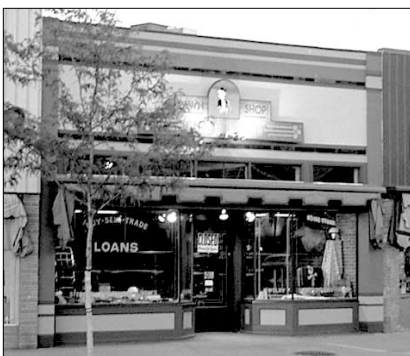
A modest building can also be renovated to be compatible with the context. In this photograph the original millinery shop front had simple moldings at the top. (Compare with the photos below.)

Years later, all original detail had been stripped from the building. (Compare with the photos above and below.)

The same building (above) after renovation exhibits the more classical features of commercial storefronts, including a painted cornice, kickplate and recessed entry.

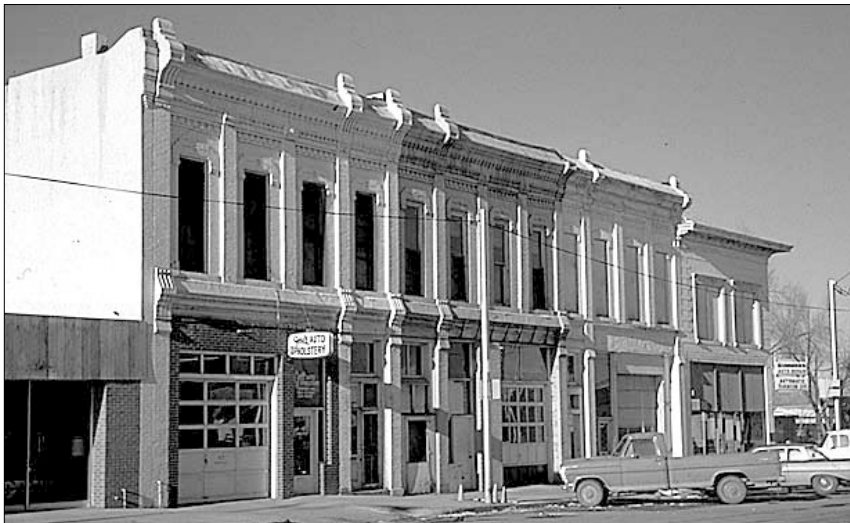
This row of buildings had lost some details over time and a monochromatic color scheme obscures the original design character. Overhead garage doors that had replaced original storefronts were later alterations without historic significance. (Compare with the “after” photograph below.)

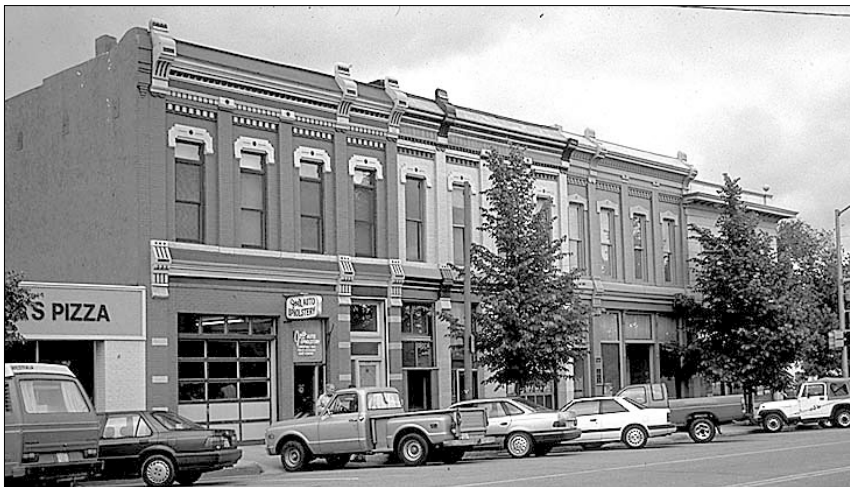
After rehabilitation, the row of buildings shown in the photograph above conveys a stronger sense of its historic character. Note that some old uses were retained, while other new uses were also introduced. Some non-contributing alterations were removed and storefronts reconstructed. One was retained, but was painted to minimize impacts.

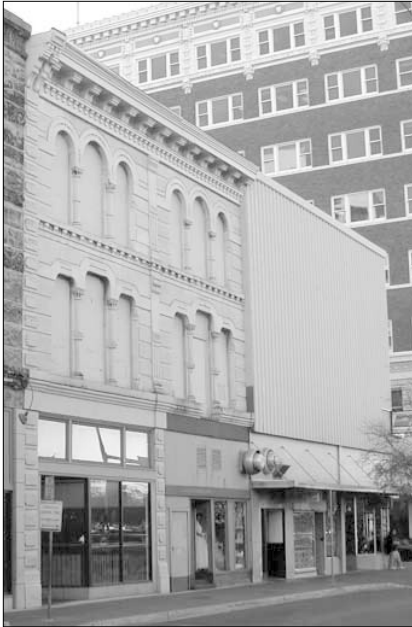
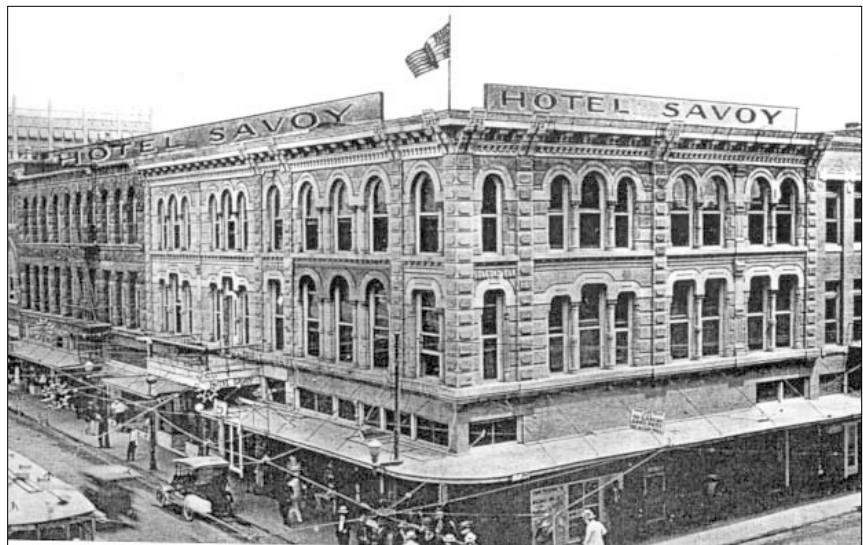
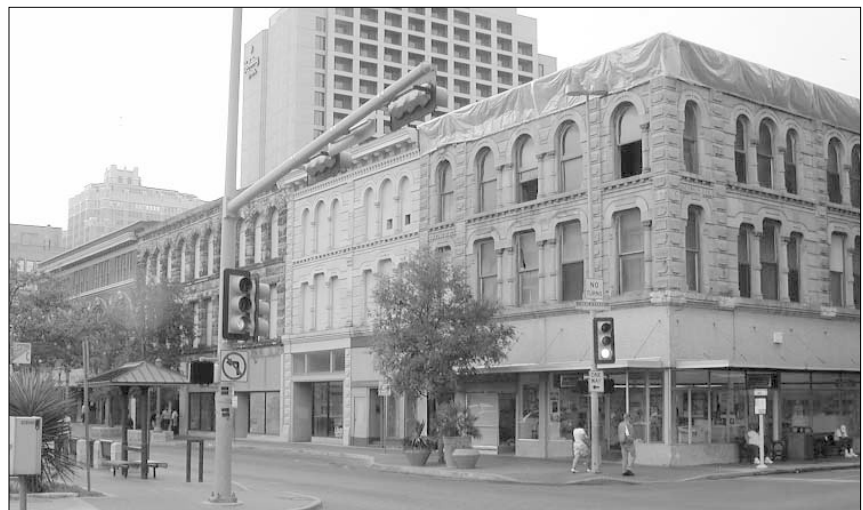
This sequence of three photographs of the Hotel Savoy demonstrates how a consideration of integrity of features and significance of a property may affect a restoration strategy.

B. In the second photograph, taken in 1999, a portion of the cornice is missing, half the upper facade is covered and remaining upper story windows are blocked. Street level storefronts also area altered and he canopy is missing.

C. In the third image, taken in 2000, the metal covering has been removed, revealing the existing conditions. Many windows remain intact, although some are damaged. Although the building has lost some key features a sufficient amount remains and the building retains its historic significance and reconstruction of the missing features is merited. Adequate information also is available on which to base the reconstruction: The historic photograph and surviving details can be used to develop accurate replacements.

A. In the first image, taken ca. 1910, documents the historic character of the building and provides clear information about the design of key details, including the cornice and canopies.

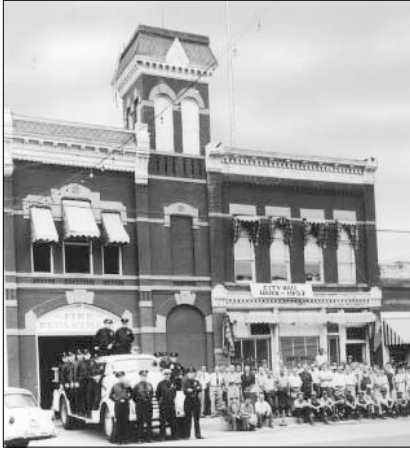
Using historic photographs can help in determining the original character. (Compare with below.)

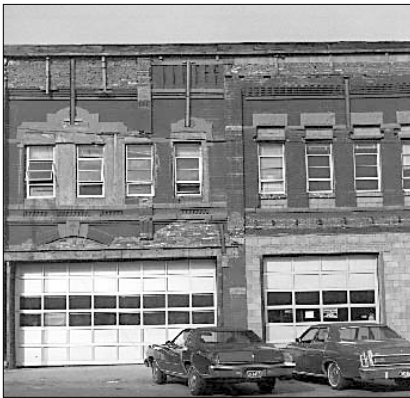
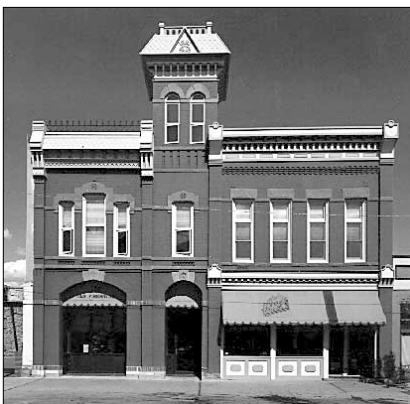
If a storefront is altered, consider restoring it to the original design. (Compare with the two photos of the same building below.)

This rehabilitation preserves surviving details and reconstructs missing ones.

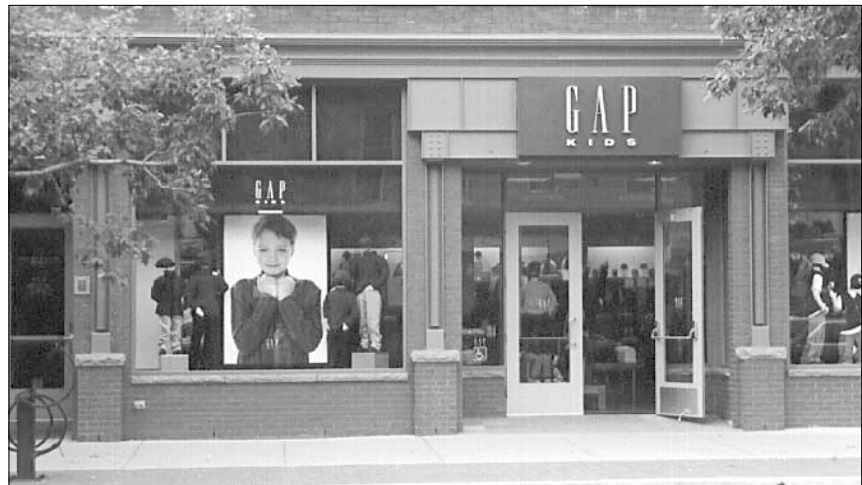
Where original details are missing, an alternative design that is a contemporary interpretation of a traditional storefront, as this one is, may be considered. The storefront still should be designed to provide interest to pedestrians.

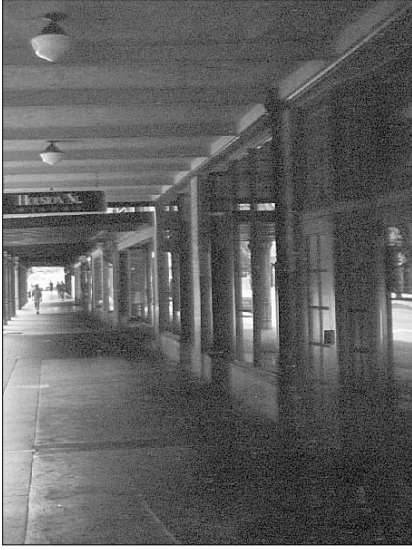
If an historically significant storefront opening has been altered, consider restoring it if the original condition can be determined. In this case, openings have been blocked down for smaller replacement windows. Returning to the original proportions is preferred.

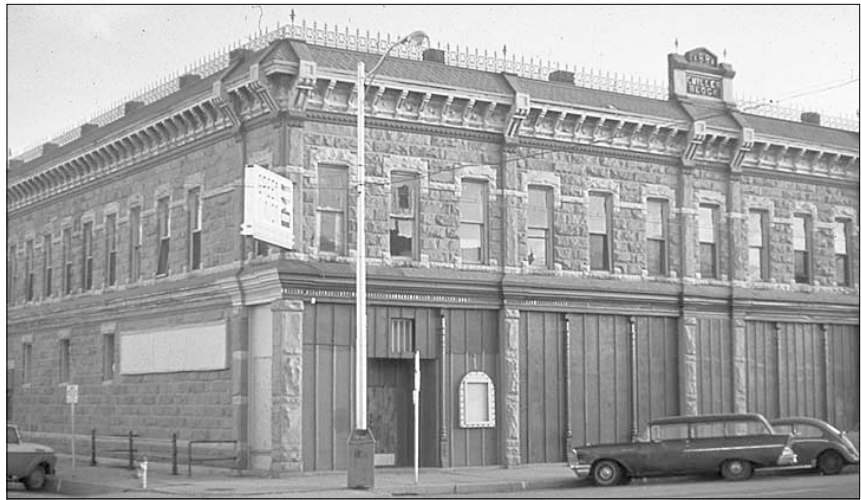
The windows in this structure were boarded and architectural details needed repair. (Compare with the photo below.)

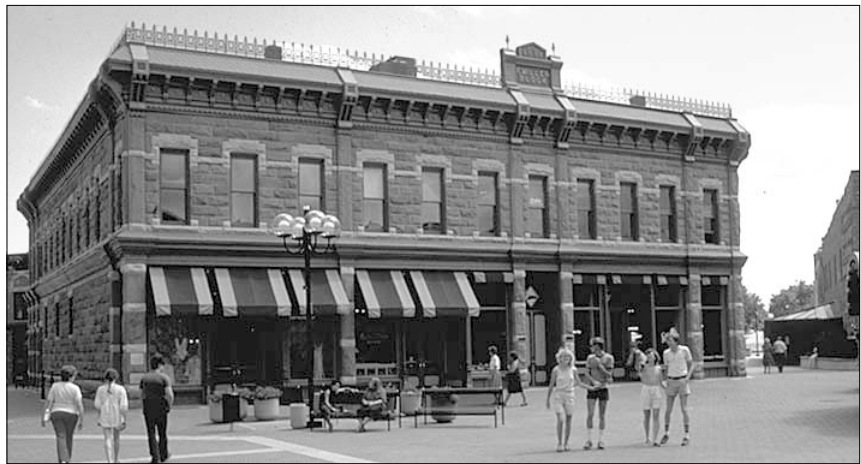
Storefront windows were reopened and upper-story windows were repaired.

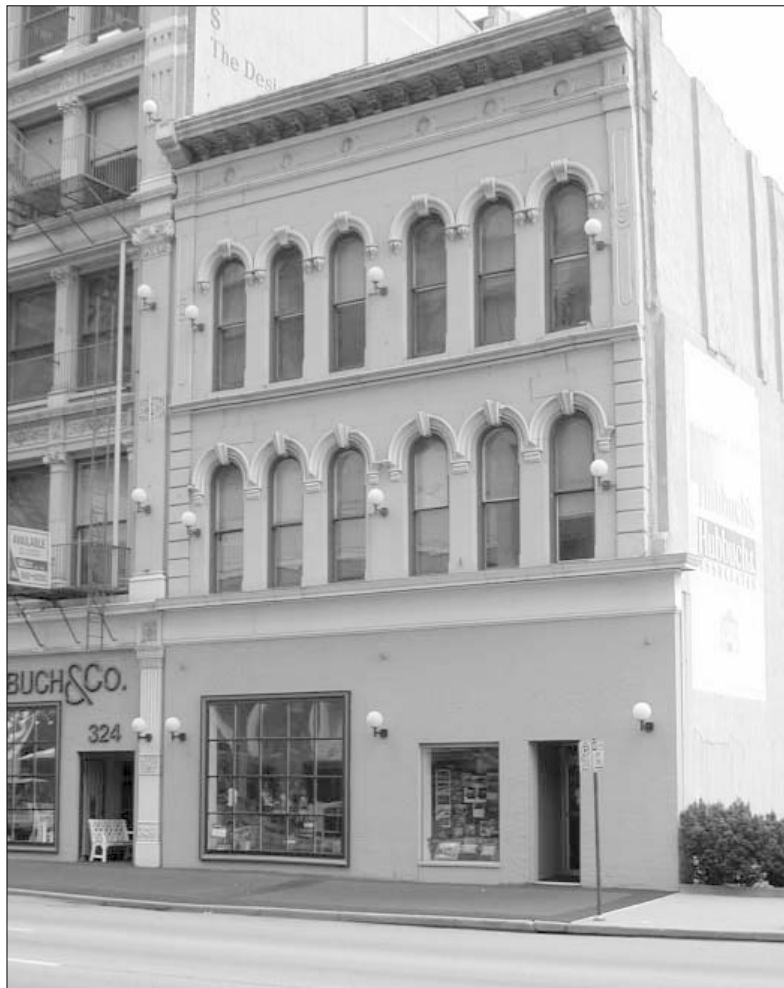
Maintain an historically significant storefront opening. Altering the windows such as in this case is inappropriate.

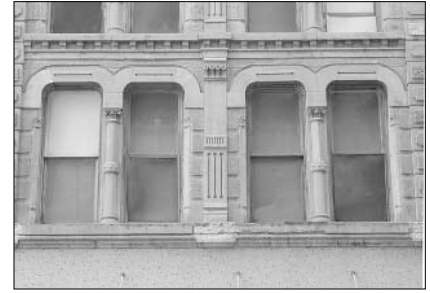
Preserve historic upper-story windows. Repair the sash, rather than replace it, when feasible.

3.11 Preserve historic upper-story windows.

- Historically, upper-story windows had a vertical emphasis. The proportions of these windows contribute to the character of each commercial storefront. Don't block them down or alter their size.
- Consider reopening windows that are currently blocked.
- Maintain the historic sash as well. Repair the sash, rather than replace it, when feasible.

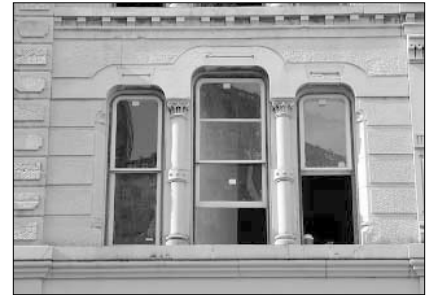
When the sash is deteriorated beyond repair, it should be replaced with materials that are similar to that which existed historically, to maintain the integrity of the building.

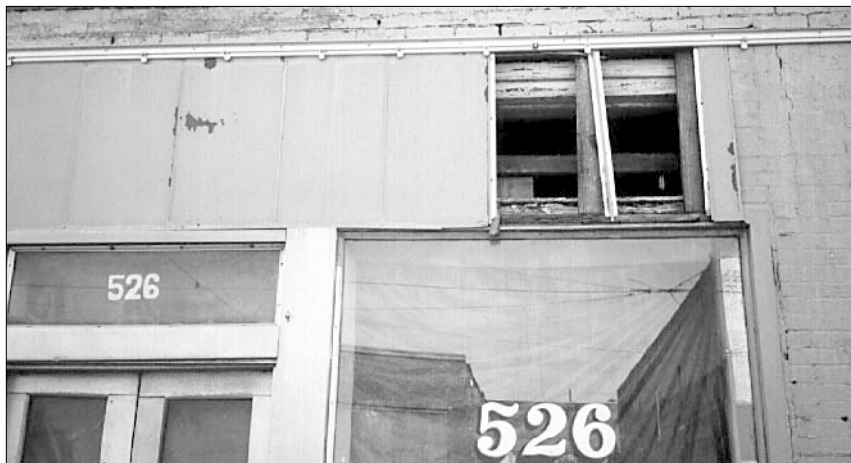
Retain the original shape of the transom glass in an historic storefront. Removing or covering up the transom opening is inappropriate.

- The upper glass band of a traditional storefront introduced light into the depths of a building. These bands are found on many historic storefronts, and they often align at the same height. The shape of the transom is important to the proportion of the storefront, and it should be preserved in its historic configuration, whenever possible.
- If the original glass is missing, install new glass. However, if the transom must be blocked, use it as a sign panel or a decorative band, but be certain to retain the original proportions.

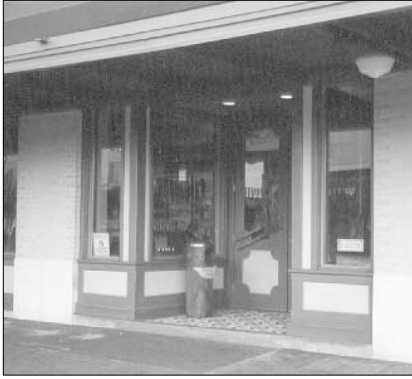
Maintain the original decorative paving within a recessed entry.

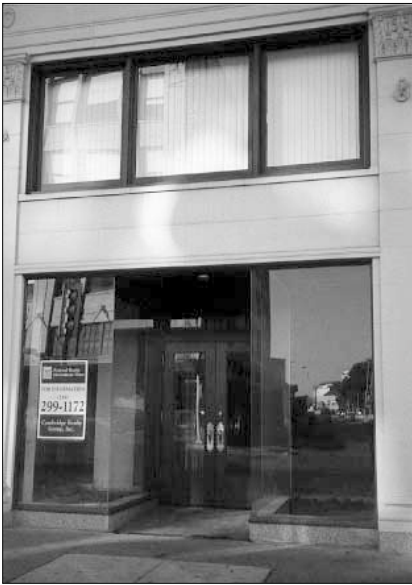
Maintain a recessed entry.

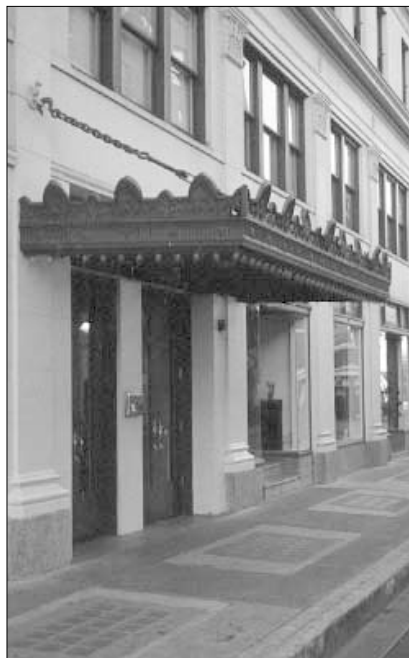
Maintain the original position and hierarchy of an entryway. Occasionally, the entry may be accented with a horizontal canopy

3.13 Where an entry is not recessed, maintain it in its original position, when feasible.

- However, it may be necessary to comply with other code requirements, including door width, swing and construction. If so, an alteration may be considered.
- In some cases, entries must comply with accessibility requirements of the Americans with Disabilities Act. Note, however, that some flexibility in application of these regulations is provided for historic properties.
- If the original storefront is missing and the location of the entry is not integral to the architectural style or period of construction of the building, it may be repositioned in keeping with the building style.

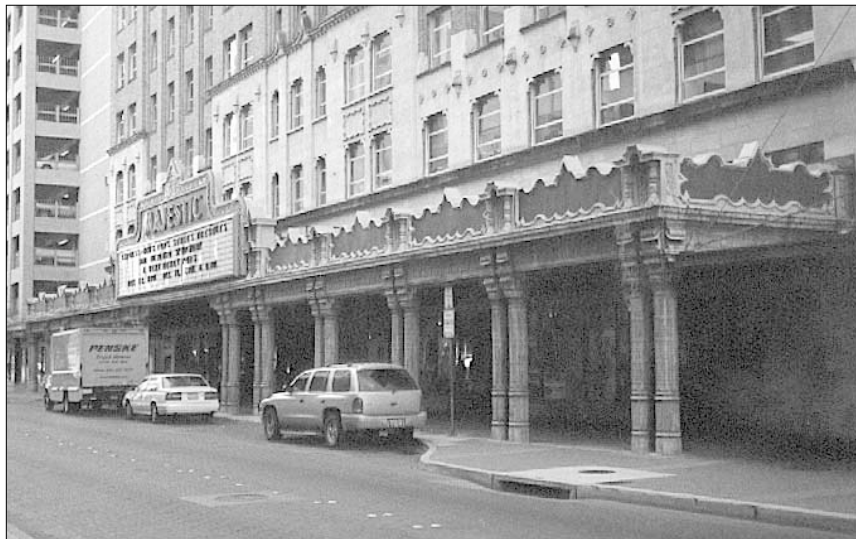
Preserve the original canopy when it is intact.

A metal canopy is appropriate on many historic building styles in San Antonio.

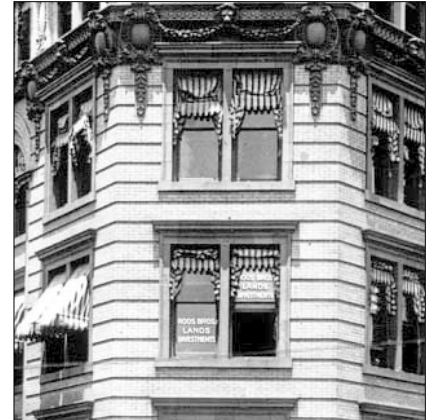
Historically awnings and especially canopies were noteworthy features on Houston Street and their continued use is encouraged, as shown in this early photo detail of the Moore Building.

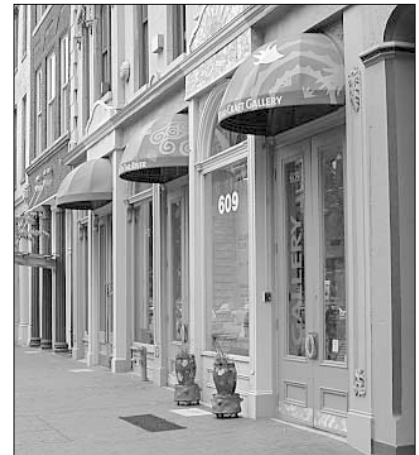
Where the original canopy is missing and no evidence of its character exists, a new design that uses the traditional elements may be considered. The canopy in this photo is inappropriate since it does not match the shape of the window opening.

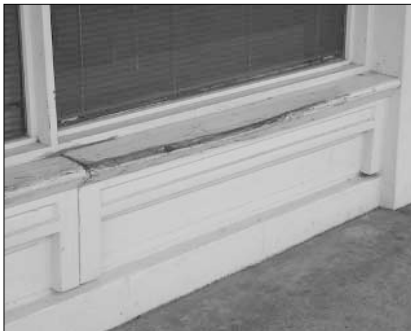
Repair the original kickplate when feasible.

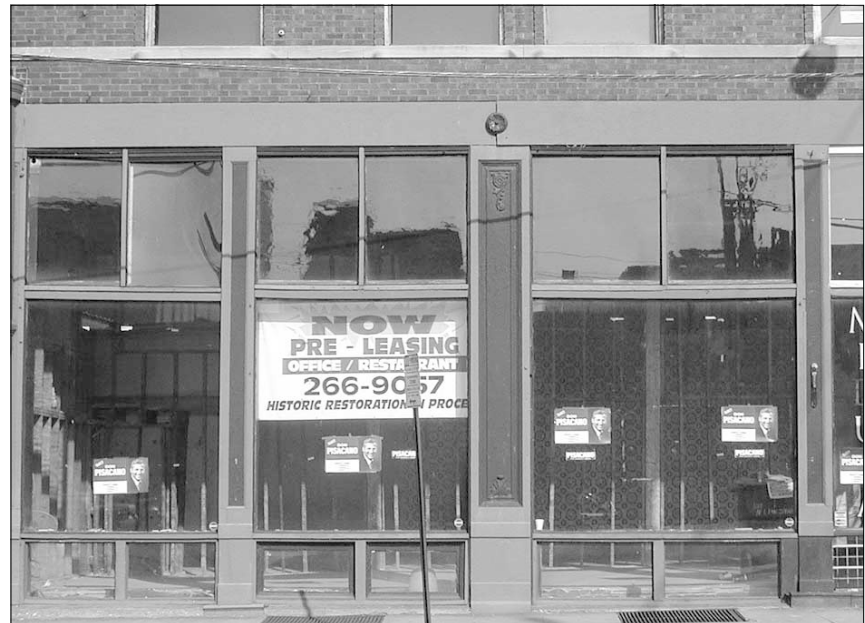
If the original kickplate is missing, develop a sympathetic replacement design. Here a transparent glass kickplate is used where a solid panel may have existed. However, the original proportions are still conveyed, which is appropriate.

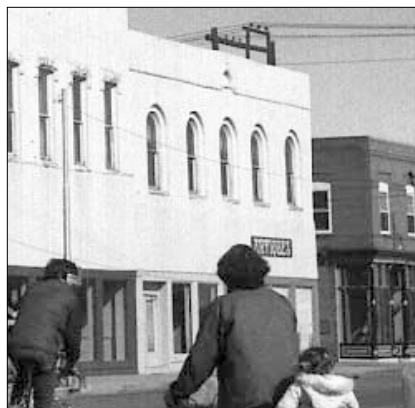
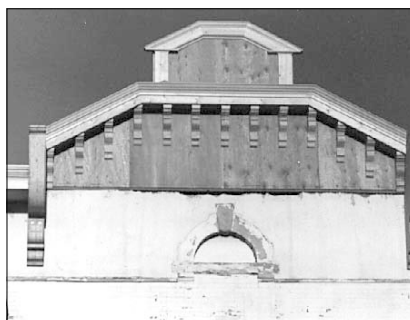
Reconstructing missing details, when sufficient information is available, is encouraged. In this case, the original cornice is missing in the photo at upper left. The central portion of the pediment is under construction, above. When completed, in the photo at lower left, the shadow lines from the cornice once again add interest to the building front.

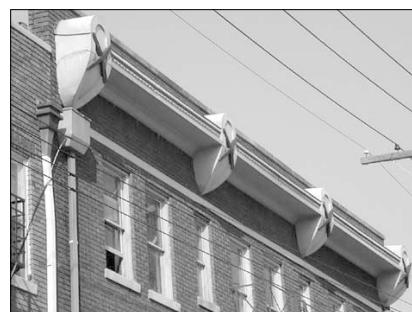
Preserve the character of the cornice line with a replacement design.

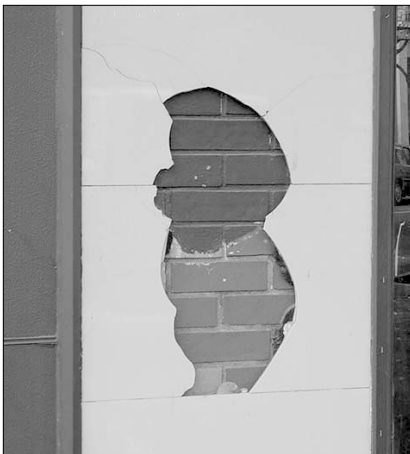
If the original material has been covered, uncover it if feasible.

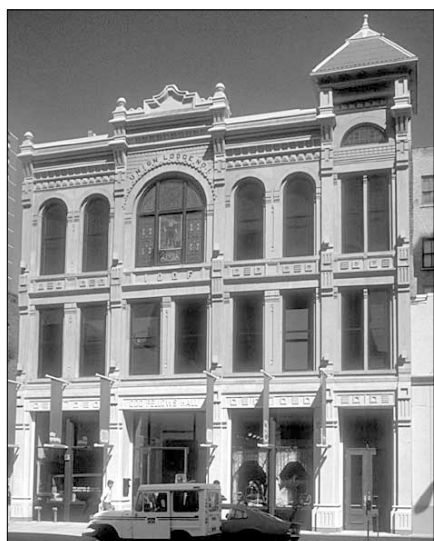
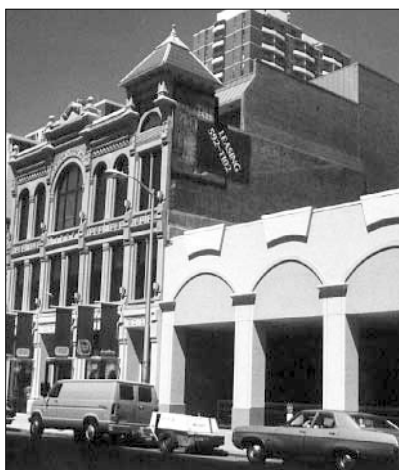
An addition may be set back to preserve the perception of the historic scale of the building. In the image on the left, the original three floors of this building are visible. In the angle view at the right, two newer floors are visible. Note how the addition cannot be seen when looking at the building straight-on because it is setback.

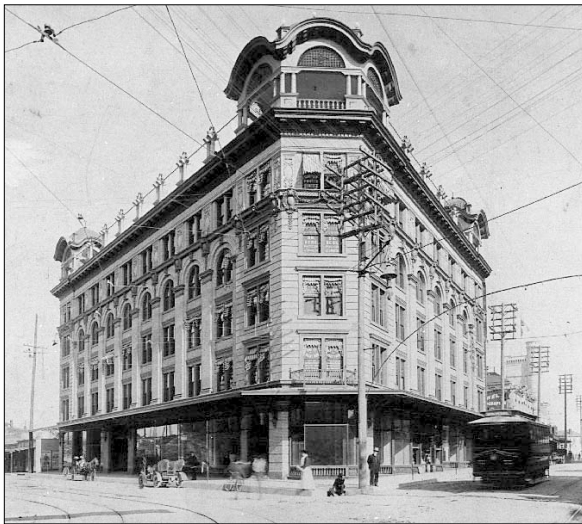
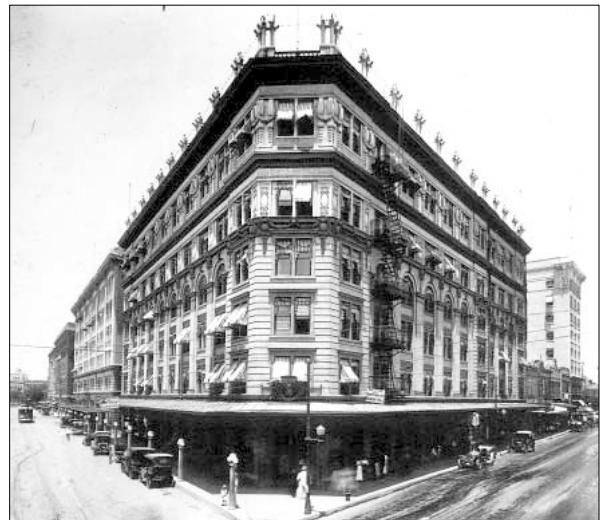
These early photos of the Moore building illustrate historic precedence for a rooftop addition. This addition can be distinguished from the original building on the left by providing a simple decorative band. Although the towers were removed, the original cornice was replaced at the top of the building.
